SPECIAL REPORT 184

LANDSLIDES IN THE HIGHWAY 101 CORRIDOR
BETWEEN WILSON CREEK AND CRESCENT CITY,
DEL NORTE COUNTY, CALIFORNIA

Prepared for
California Department of Transportation
New Technology and Research Program
Office of Infrastructure Research
Project F99TL34

DEPARTMENT OF CONSERVATION
CALIFORNIA GEOLOGICAL SURVEY
801 K STREET, MS 12-32
SACRAMENTO, CA 95814

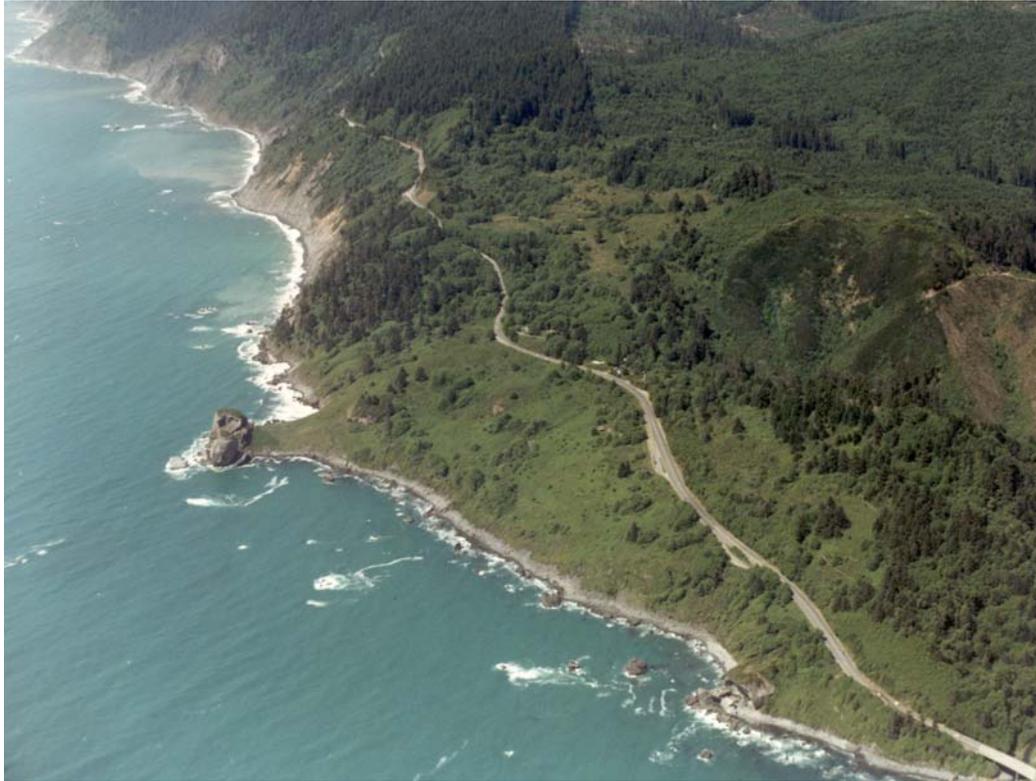
Figure 2. View north over Last Chance Grade area. From the Wilson Creek Bridge at lower right, Highway 101 crosses an earthflow complex above Footsteps Rock (left center), then crosses into much more resistant bedrock characterized by deep-seated rock slides and surficial debris slides.

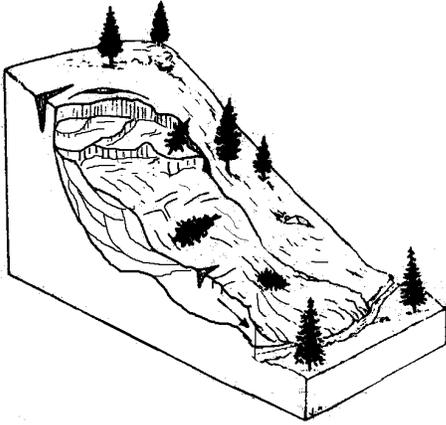
EARTH FLOW: A landslide composed of mixture of fine grained soil, consisting of surficial deposits and deeply weathered, disrupted bedrock. The material strength is low through much of the slide mass, and movement occurs on many discontinuous shear surfaces throughout the landslide mass. Although the landslide may have a main slide plane at the base, many internal slide planes disrupt the landslide mass leading to movement that resembles the flow of a viscous liquid.

Earth flows commonly occur on less steep slopes than rock slides, in weak, clay-rich soils or disrupted rock units. Slopes are commonly from 10% to as steep as 30%, although steeper slopes may be found in headscarp areas and where landslide toes are being eroded. Movement of a slide mass along numerous curved failure surfaces leads to an irregular steep headscarp at the upper boundary of the slide. Immediately below the headscarp is a series of blocks that are commonly rotated so they are less steep than the surrounding hillslopes. Below the bench, the slide mass is made up of many smaller masses which may move as intact masses for a time then break up into smaller masses and flow on a multitude of failure surfaces. The flowage of weak material with blocks of relatively intact material leads to a lumpy "hummocky" slope that is typical of large earth flow areas. The lower parts of the slopes usually bulge outward and are steeper than the surrounding slopes.

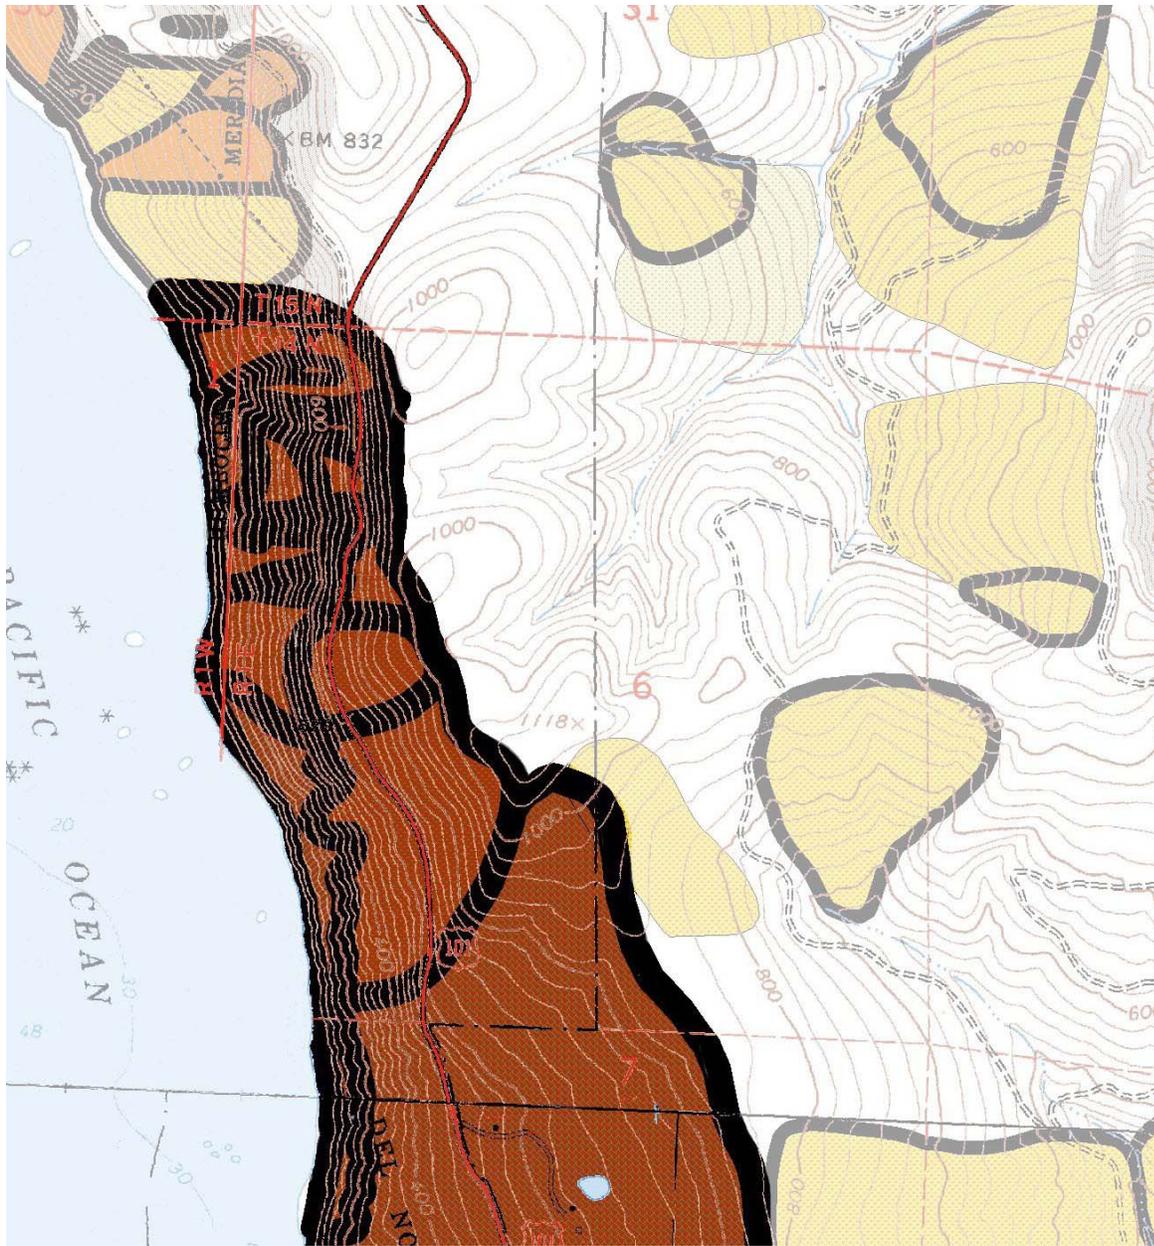
Figure 4d. As Highway 101 leaves the ridge and begins to traverse the Last Chance Grade, it enters a series of landslides. These landslides are both large, deep-seated slides and shallower debris slides. The shallow debris slides affect the area below the road and have the potential to undermine the road. Slopes above the road also show scars of past debris slides and debris flows. As a result, the entire segment of roadway classified could be affected by large deep landslides and shallow fast-moving slides such as debris flows and rock falls. Caltrans has constructed retaining walls in the past several years to mitigate the risk from the smaller slides below the road. The deep rock slides have the potential to move several feet to tens of feet rapidly in response to exceptionally wet seasons or earthquake shaking.
